Pseudotumor Associated with Dall-Miles Cable Breakage Following Revision Total Hip Arthroplasty: A Case Report

Abstract

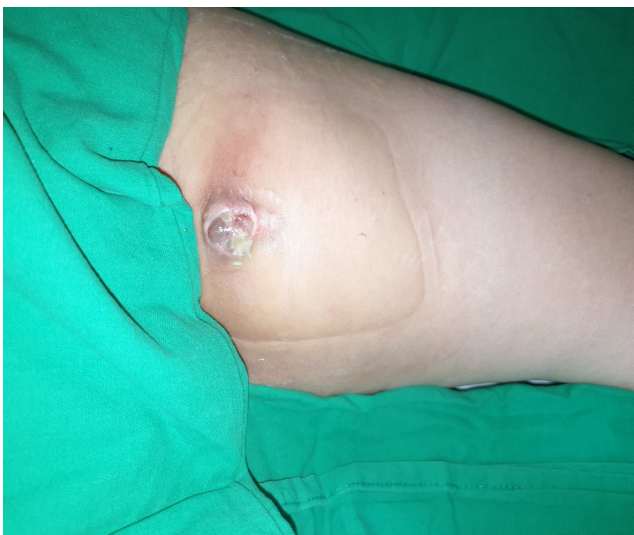
Fig. 1. Initial findings. A 3×3 cm-sized suppurative ulcerative lesion on the medial surface of the left thigh.

Upon initial clinical examination, a 3×3 cm-sized suppurative ulcer and a palpable mass were found on the anteromedial aspect of the patient's left thigh (Fig. 1). Physical examination revealed no other complaints or instability of the hip joint. The patient did not complain of chills, fever, or systemic symptoms. Initial laboratory findings showed that the white blood cell (WBC) count was within normal limits, but some inflammatory markers were elevated; WBC count was $8.4 \times 10^3/\text{mm}^3$ (normal range, $4\text{--}10 \times 10^3/\text{mm}^3$), erythrocyte sedimentation rate (ESR) was 72 mm/hr (normal, <20 mm/hr), and C-reactive protein (CRP) level was 1.39 mg/dL (normal, <0.5 mg/dL). Methicillin-resistant *Staphylococcus epidermidis* was cultured from the external wound.

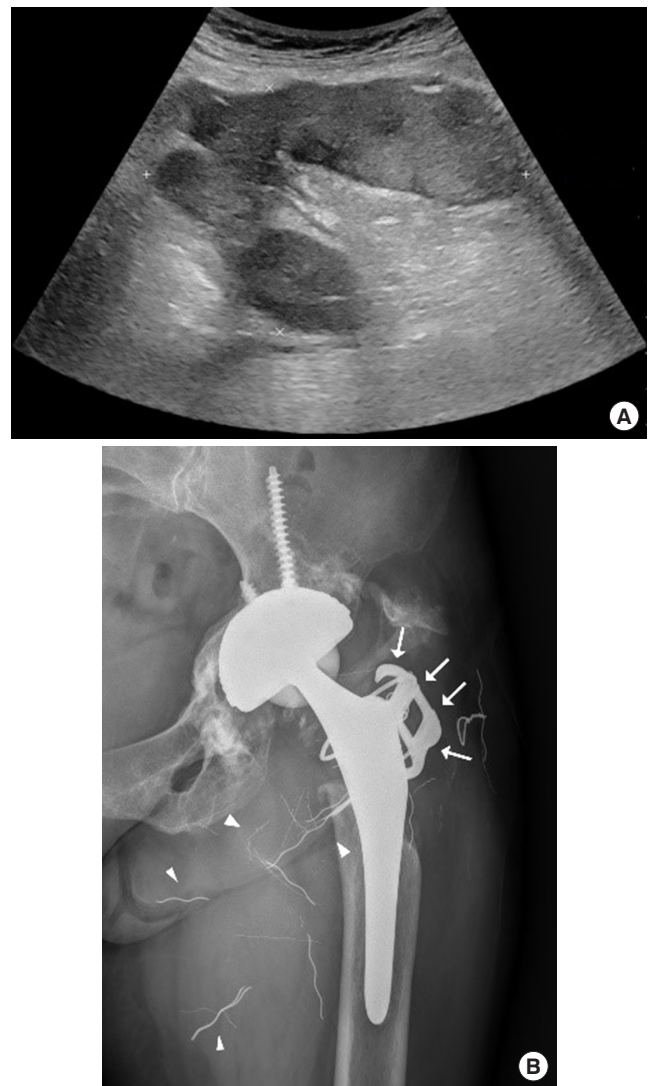
Fig. 2. Preoperative findings. (A) An ultrasound scan shows an irregularly-shaped cystic mass with posterior acoustic enhancement. (B) Anteroposterior radiography of the left thigh shows the Dall-Miles cable grip system (arrows) and multiple metal fragments of the broken cable (arrowheads).

An ultrasound scan of the left thigh confirmed a heteroechoic encapsulated cystic mass with internal debris (Fig. 2A). Radiography of the thigh showed breakage of the Dall-Miles cable grip system that had been used to fix the trochanteric osteotomy. Metal debris and multiple filaments of the broken cable were disseminated and had migrated to the medial aspect of the left thigh (Fig. 2B). Computed tomography (CT) demonstrated a $5.8 \times 14.2 \times 12.1$ cm-sized mass medial to the left thigh. The irregularly-shaped mass contained deposits of met-

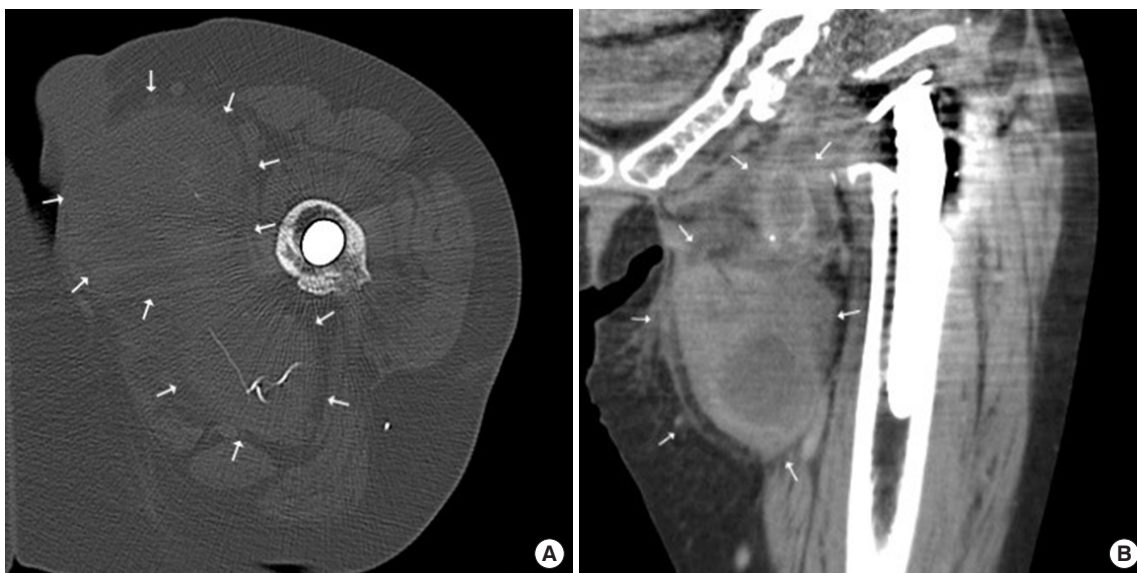
Fig. 3. Preoperative computed tomography (CT) of left hip. (A) A transverse view of non-contrast CT shows a 5.8×14.2×12.1 cm-sized mass with internal metal fragments (arrows). (B) A coronal view of enhanced CT shows invasion of the peripheral enhanced large mass into the adductor longus muscles (arrows).

al debris and multiple metal filaments. Furthermore, the mass appeared to communicate with the ulcerative lesion and had invaded into the adductor longus muscle (Fig. 3A). Enhanced CT showed low-density central tissue and peripheral enhancement. There was no lymphatic enlargement or inflammatory signs in the surrounding tissues (Fig. 3B).

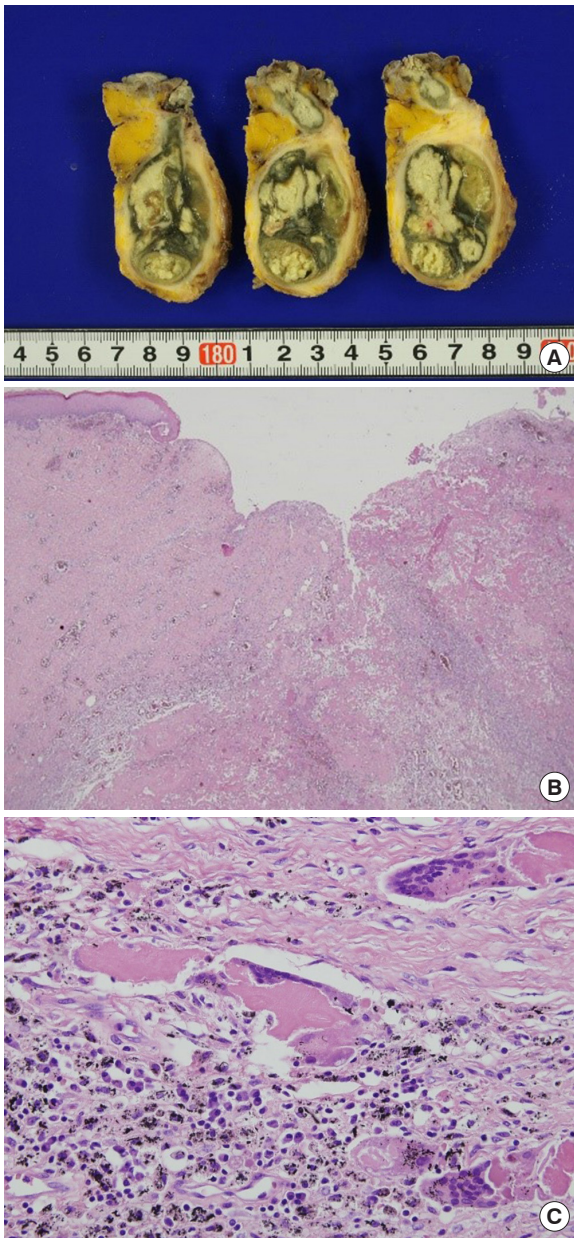
Fig. 4. Biopsy findings. (A) Gross specimens show a granuloma with black pigments and multifocal necrosis. (B) Acute and chronic inflammation with ulceration (H&E, $\times 40$). (C) Widespread lymphoplasmacytic and histiocytic infiltration with metallic black pigments and foreign-body reaction (H&E, $\times 400$).

Histopathological examination of the resected specimen revealed granulomatous inflammation with metallic debris and lymphocytic infiltration, but there were no neoplastic features (Fig. 4). The mass was confirmed to be a pseudotumor originating from the deposition of metal debris.

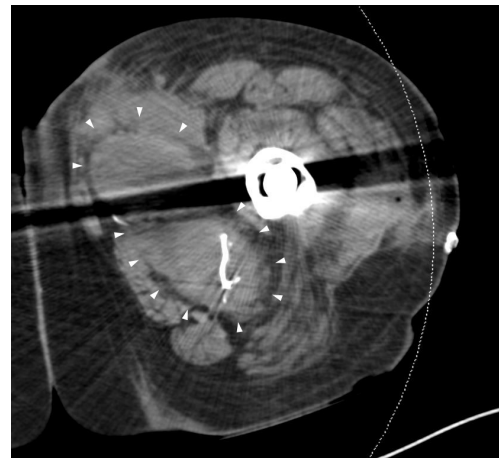
Fig. 5. Computed tomography of recurrent pseudotumor. Recurrent pseudotumor with internal metal fragments on the postero-medial aspect of the left thigh (arrowheads).

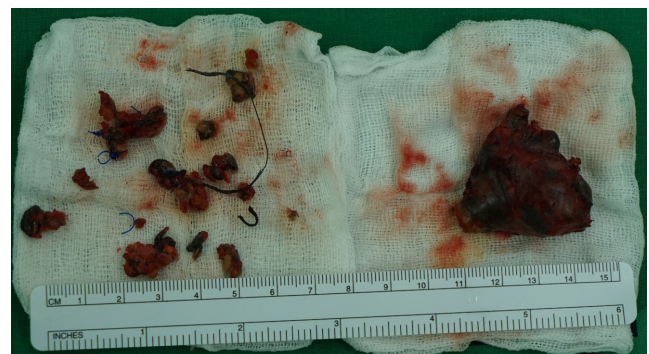
Fig. 6. Specimens from the secondary operation. Removed metal filaments and fragments of the broken Dall-Miles cable and the recurrent pseudotumor.

In this case, despite the breakage of the Dall-Miles cable, the implant was intact without any instability or limited movement of the hip joint, so only pseudotumor resection was performed without THA revision. In the first operation, due to insufficient surgical exposure, the deep-seated pseudotumor in the posterior aspect of the femur was not completely resected and multiple filaments of a broken cable could not be sufficiently removed. Nine months later, the pseudotumor recurred. In the second operation, a sufficient surgical field was secured through simultaneous anterior and posterior approaches, complete resection was performed, and the metal filaments were removed completely.

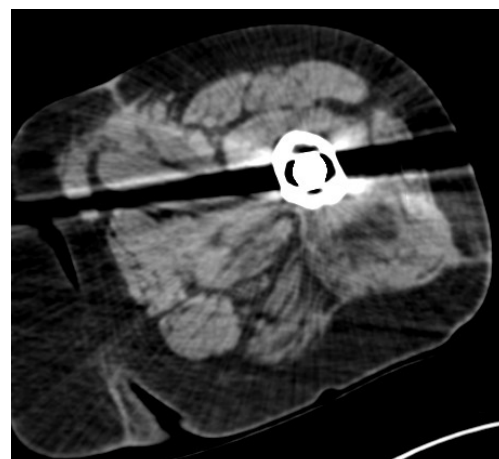
Fig. 7. Postoperative computed tomography (CT) of the left hip. Four months after the second operation, there is no evidence of recurrence of pseudotumor, and complete removal of metal fragment is confirmed through a CT scan.
