Seismic Performance of Existing RC Structural Walls Retrofitted in Flexure by Wall End Plate

Abstract: A study was conducted for the flexural retrofit of an old apartment house composed of a reinforced concrete (RC) shear wall structure. For the shear wall, a vertical retrofit was performed to both ends of the wall targeting the slender wall to improve the flexural performance. The retrofit materials were steel plate, epoxy, and non-shrink grout, and they were connected to the existing shear wall using post-installed chemical anchors. The concrete at the wall ends was broken and retrofitted as much as necessary to maintain the shear wall's length. The points to be noted are the fracture of the welded part of the flexural retrofit and the chemical anchor's pulling. After the real scale specimen was fabricated by simulating the existing shear wall, the retrofit effect was experimentally verified by breaking the wall ends, retrofitting the ends, and applying repeated cyclic lateral loads. A total of three specimens were fabricated and retrofitted using steel plates and steel tubes. Since this experiment evaluated the flexural performance, the experiment was performed with a cantileve

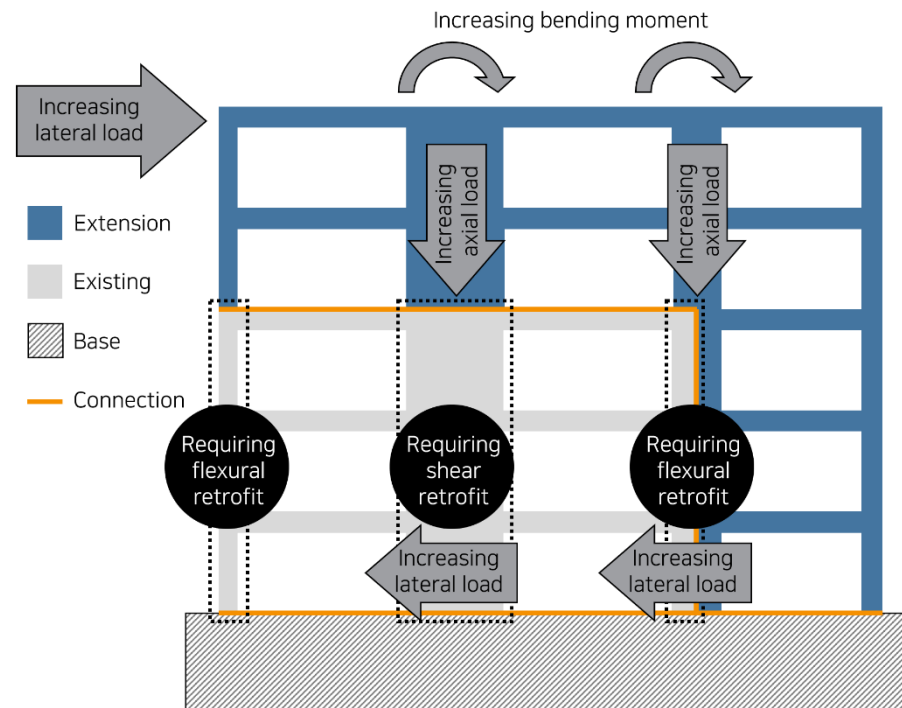
Figure 1. Requirement of shear wall retrofit [31].

For example, in Korea, the Housing Act has been established to allow vertical extension of three floors for apartment houses with 15 floors or more. In this case, since the height and the self-weight of the existing building increase, a structural retrofit may occur in some shear walls, and the flexural strength within about 50% compared to the existing strength needs to be increased [31]. Figure 1 shows the retrofit necessity according to the increase in load applied to the shear wall structure.

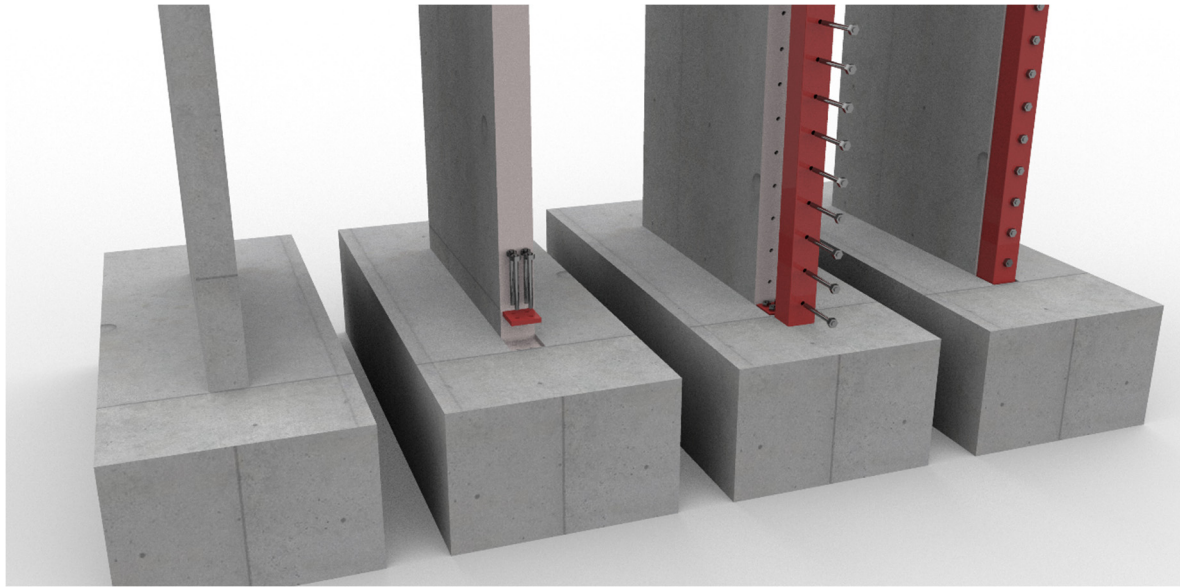
Figure 2. Perspective view of shear wall flexural retrofit using steel tube.

In Figures 2 and 3, the flexural retrofit process using steel is expressed. (a) As the existing RC shear wall, the wall connected to the foundation was modeled. (b) The shear wall's end was broken to the required length, and preliminary work was performed to conceal the base plate into the concrete. For steel plate retrofit, the concrete cover thickness was chipped. In the steel tube retrofit, the wall end was broken by the steel tube's size. The base plate was for connecting the steel plate or the steel tube to the foundation or the slab. (c) This is the work of connecting the base plate to the foundation or the slab using a post-installed chemical anchor. It was required not only in the lower part but also in the upper part. The base plate was connected using four anchors. After that, the steel plate or the steel tube was placed on the base plate and connected to the existing shear wall using a post-installed chemical anchor. The steel plate and the steel tube needed to be perforated in advance to use the anchor. (d) The base plate and the steel plate or the steel tube were connected by welding. Since the welding line between the steel plate and the base plate was short, care was taken, as it could have split at the welded line when subjected to tensile force if not properly constructed. In the case of a steel tube, after welding the lower part, the non-shrink grout was filled into the steel tube through an injection pipe from the top. A slight gap occurred between the steel plate or the steel tube and the existing shear wall after retrofitting. It could be easily filled through liquid epoxy, but this was not a necessary procedure.

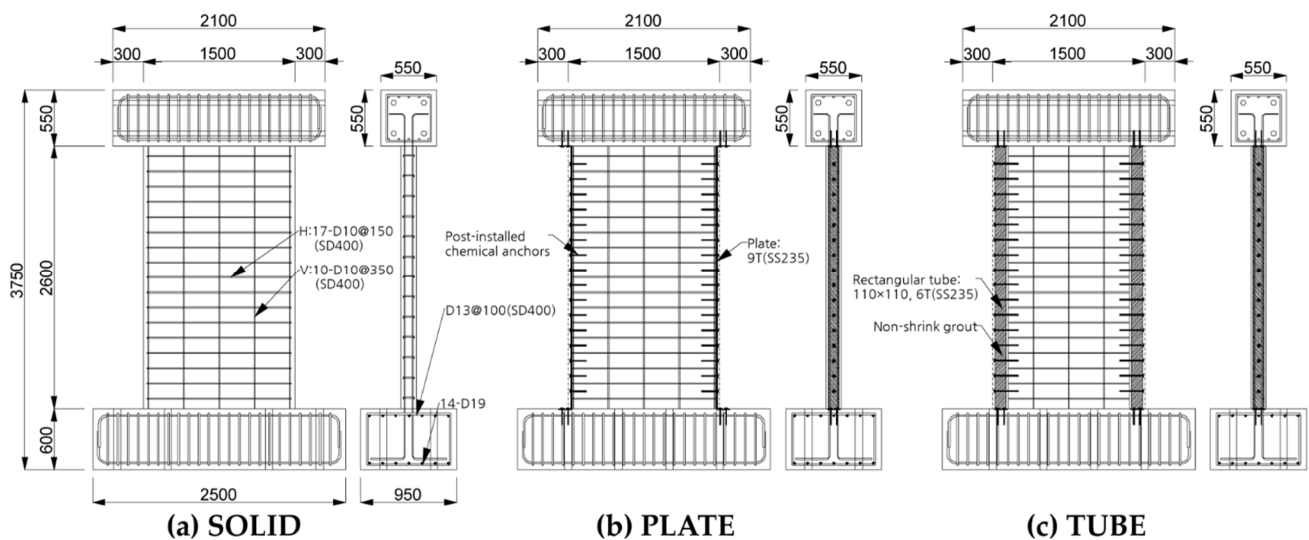
Figure 4. Elevations of the specimen.

The plan of the specimen is shown in Figure 4. Compared to the SOLID specimen, the retrofitted specimens had a length shorter than 1500 mm before finishing. The PLATE specimen could be retrofitted with a short excavating length because the thickness of the steel plate (9 mm) and the concrete cover thickness were considered. Since the TUBE specimen had a rectangular steel tube (110 × 110 mm), the concrete breaking length was longer than the PLATE specimen. After the retrofit was finished, a dry finish such as a gypsum board or a wet finish such as finishing grout could be used outside so that there was no difference before and after the retrofit. However, it was not finished to observe the behavior of the retrofit during the experiment.

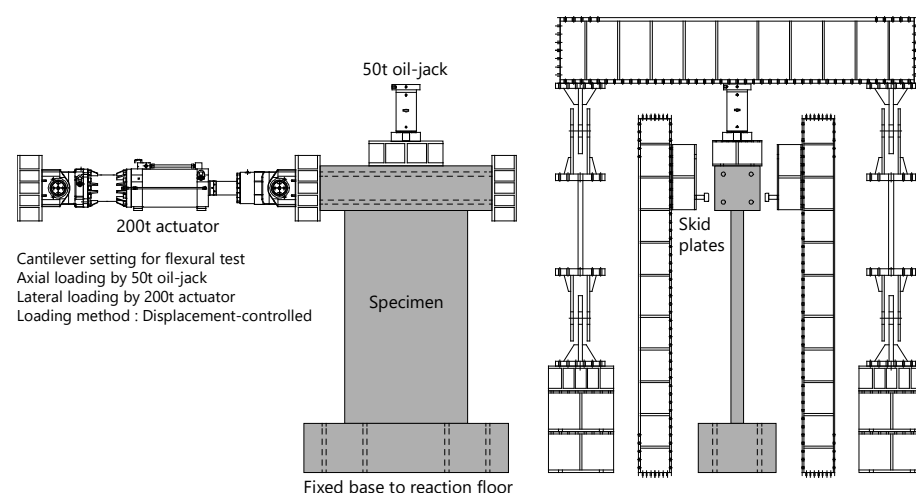
Figure 5. Test setting scheme of cantilever-type shear wall lateral loading.

A base with a length of 2500 mm, a depth of 950 mm, and a thickness of 600 mm was manufactured in the lower part, and the rebars were densely arranged to realize a fixed end. Eight large-diameter bolts fixed the foundation, and fixed hardware was used on both sides to prevent lifting or sliding during the experiment. A displacement transducer was installed to measure the movement of the foundation to eliminate the error. After setting the specimen, 15% of ALR was loaded using an oil jack, and then lateral loading was performed. The lateral loading was made in the displacement controlled, and the drift ratio increased to 0.25% for the elastic zone and initial crack observation and then increased in the order of 0.5% and 1%. The experimental setting is shown in Figure 5.

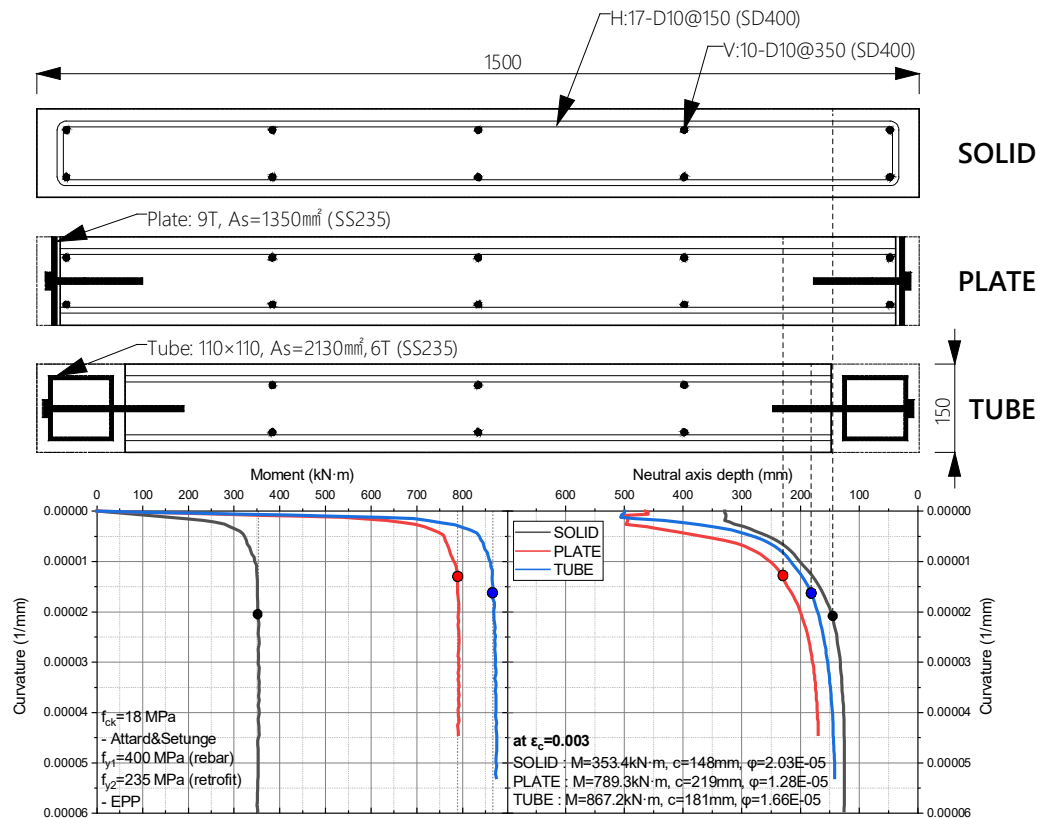
Figure 6. Results of cross-sectional analysis of the specimen. Cross-section (**top**); moment–curvature and neutral axis–curvature relationship (**bottom**).

The sectional flexural analysis was performed based on the specimen's cross-section, as shown in Figure 6. The specimens' cross-section was divided into 1 mm intervals using a CAD program, and each piece was classified by the material. Furthermore, the area and

As a result of the cross-sectional analysis, the SOLID showed a moment of 353.4 kN·m, and the neutral axis depth was 148 mm. The retrofitted PLATE specimen presented a moment of 789.3 kN·m, the neutral axis depth was 219 mm, and the flexural strength increased by 123% compared to the SOLID specimen, while neutral axis depth increased 71 mm. The TUBE specimen exhibited a moment of 867.2 kN·m and had the highest retrofit effect. The neutral axis depth slightly decreased to 181 mm, but the flexural strength increased by 145% compared to the SOLID specimen. When the tensile force at the outermost rebar and the steel yield was simply calculated, the tensile force when the PLATE specimen's rebar and steel plate at the wall end were summed was 418.5 kN. If only the tensile force was calculated at the TUBE specimen's steel tube yielding, it was 500.6 kN,

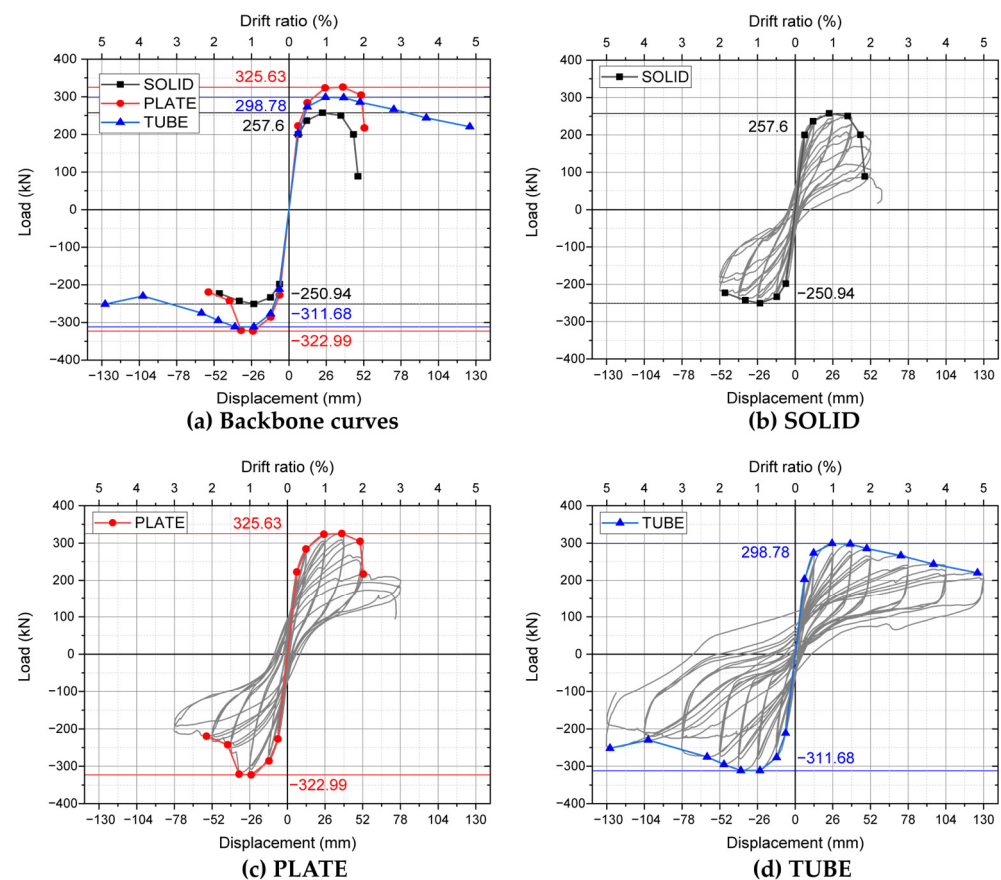
**Figure 7.** Load–displacement relationship.

The lateral loading test results of the shear wall specimen are shown in Table 3 and Figure 7. Compared to the existing wall, the flexural strength of the retrofitted specimen was increased, and, in the case of the TUBE specimen, the ductility was remarkably improved compared to the existing wall. The maximum load of the SOLID specimen (existing wall) was 257.6 kN and 250.94 kN. In this result, compared to 135.92 kN, which was the cross-sectional analysis result, a large error occurred with a 190% load. The difference between the cross-sectional analysis of the SOLID specimen and the test result was considered due to the negligence to properly simulate the 15% ALR in the cross-sectional analysis, underestimating concrete deformation capacity and the failure to reflect the tensile hardening behavior of rebars. In the PLATE specimen, the maximum load was 325.63 kN in positive loading and 322.99 kN in negative loading. Compared to the sectional analysis results, the maximum load could be predicted slightly, with 107% and 106%. In the TUBE specimen case, the positive loading force was 298.78 kN, and the negative force was 311.68 kN, and the load was reduced compared to the PLATE specimen. Compared to the cross-sectional analysis, it was 90% and 93%, which was lower than the analysis result. Unlike the cross-sectional analysis, the TUBE specimen’s flexural strength was lower than that of the PLATE specimen, which appeared to be due to the anchor’s bond failure connecting the base plate with the steel tube and the foundation. The displacement ductility ratio was calculated by comparing the yield point of the outermost tensile rebar or retrofit material and the maximum 80% load. It was calculated as 4, 8, 16 in the order of SOLID, PLATE, and TUBE. As shown in the load–displacement relationship, the maximum load was reached at the drift ratio 1% in the TUBE specimen, and the load gradually decreased.

On the other hand, in the SOLID specimen and the PLATE specimen, the load rapidly decreased after reaching the maximum load. The maximum displacement also experienced up to 5% of the TUBE specimen compared to 2% of the SOLID specimen. As expected, it was judged that the highest displacement ductility ratio was due to the high compression resistance of the steel tube filled with non-shrink grout retrofitted at the wall end of the TUBE specimen.

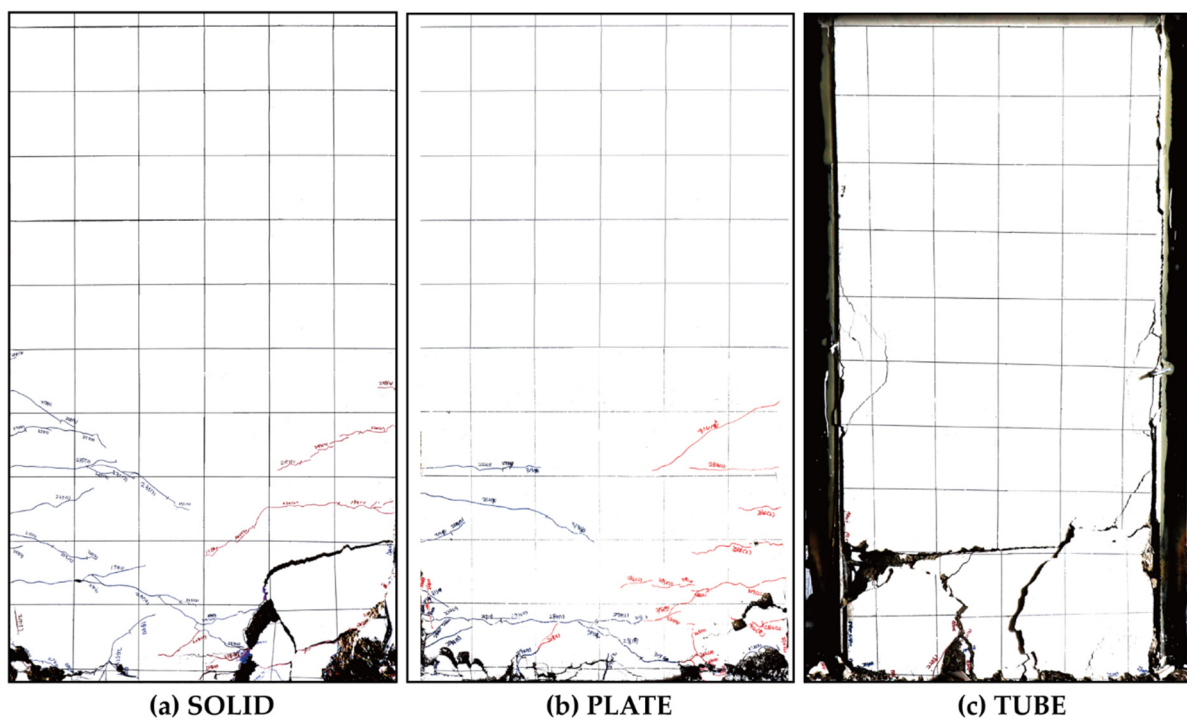
Figure 8. Crack pattern of specimens after experiment.

Figure 8 shows the crack pattern for each specimen. One cell was 250 mm long and was drawn on the surface of the specimen before the experiment to determine the location of the crack easily. The SOLID specimen showed a typical flexural failure pattern. In the drift ratio 2%, a rapid load reduction was observed. As a load of less than 100 kN was acquired, crushing occurred at the compression edge, and buckling of the outermost longitudinal rebar was observed. In the case of the PLATE specimen, a similar pattern to that of the SOLID specimen appeared. At the drift ratio 2%, a rapid load reduction was observed as was buckling of about 2 mm between the anchors in the lower part. After that, a load of 200 kN was expressed by applying up to 3% of the drift ratio, and a concrete crushing was observed. Compared to the SOLID specimen, cracks or peeling were concentrated in the lower part. A peculiar crack pattern was observed in the TUBE specimen. A crack was observed between the steel tube and the existing wall during the lateral loading, but there was no flexural crack on the existing wall's surface as in the SOLID specimen until the maximum load was reached. After reaching the maximum load, horizontal and vertical cracks appeared in the lower part, but the cracks did not progress. Additionally, a cone-shaped crack was observed around the anchor connecting the steel tube and the existing wall, and the experiment was terminated, as the concrete below the height of about 550 mm was abruptly split in the second cycle of 5% drift ratio. In the crack pattern, typical flexural or shear cracks were not observed, and the shear wall behavior seemed to be concentrated on rocking, a phenomenon that the wall was separated and lifted from the foundation. As shown in Figure 8c, the lower part's concrete was destroyed as it split back and forth in the middle of the thickness direction up to the lower two compartments below the height of 550 mm.

Another reason why the TUBE specimen's retrofit material did not effectively resist the tensile force was the crack pattern. As shown in Figure 8c, almost no cracks on the wall surface occurred before reaching the maximum load, and cracks were concentrated in

the connection part between the steel tubes and the existing wall. In particular, the major crack that occurred horizontally at the height of 550 mm from the bottom was the part where the post-installed chemical anchor was located, and after it was destroyed, it was damaged to the extent that all the chemical anchors were exposed. If it resists the tensile force effectively, cracks must occur due to flexural tensile stress. The retrofit material was peeled off by compression from the existing wall, and the lower part of concrete in the existing wall was split. Besides, it was judged that the transverse rebar of the existing wall was cut in the wall end to maintain the shear wall's length, and the development was lost. If the transverse rebars were not cut like the SOLID and the PLATE specimens, the wall splitting failure pattern like the TUBE specimen would not have been observed.

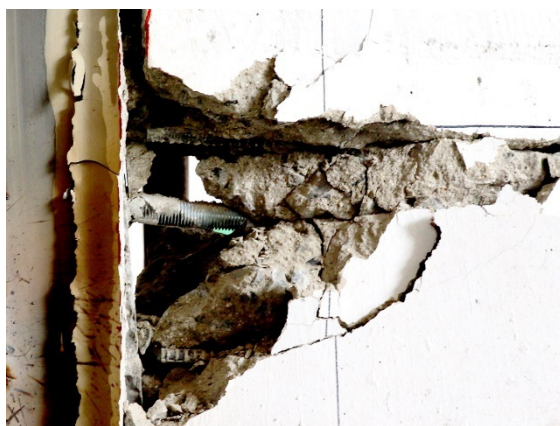
Figure 10. Damage around the anchor of TUBE specimen. (a) Damage to anchor part between steel tube and existing wall; (b) Retrofit–foundation bond failure (estimated pull-out failure).

Figure 10a shows the failure of the steel tube-existing wall connection observed after the end of the experiment of the TUBE specimen. Rectangular steel tubes filled with non-shrink grout at the ends were retrofitted, and this retrofit was connected to the existing wall using post-installed chemical anchors. Figure 10b is the rocking observed during the experiment after bond failure at the anchors to connect between the steel tube and the foundation. Post-installed chemical anchors were attached at 150 mm intervals in the middle of the wall thickness, and it seemed to damage the existing wall with retrofitted undergoing repeated cyclic loads. Additionally, unlike the SOLID or the PLATE specimens, there was no out-of-plane transverse rebar, thus it was considered that the splitting failure of the existing wall occurred. In the TUBE specimen, the length was reduced to 80% of the existing wall's length to attach the rectangular steel tube as the retrofit material. If the retrofit material and the existing wall were separated, the transverse rebars in the existing wall from which the development part was cut were the only shear reinforcements in the specimen. The lower part of the shear wall was split along the anchor line in the wall's thickness direction, and cracks occurred horizontally along the anchor recess. Anchors were embedded between the rebars to minimize the effect on the transverse rebars of the existing wall, however, the anchors were not constrained in the out-of-plane and the in-plane directions, which seemed to be fatal. In the PLATE specimen retrofitted with steel plate, no damage occurred around the anchor recess. This seemed to be the effect of the stiffness of the retrofit material. In the rectangular steel tube, the stress was concentrated due to high stiffness, and it was judged that a problem occurred between the steel tubes and the existing wall.

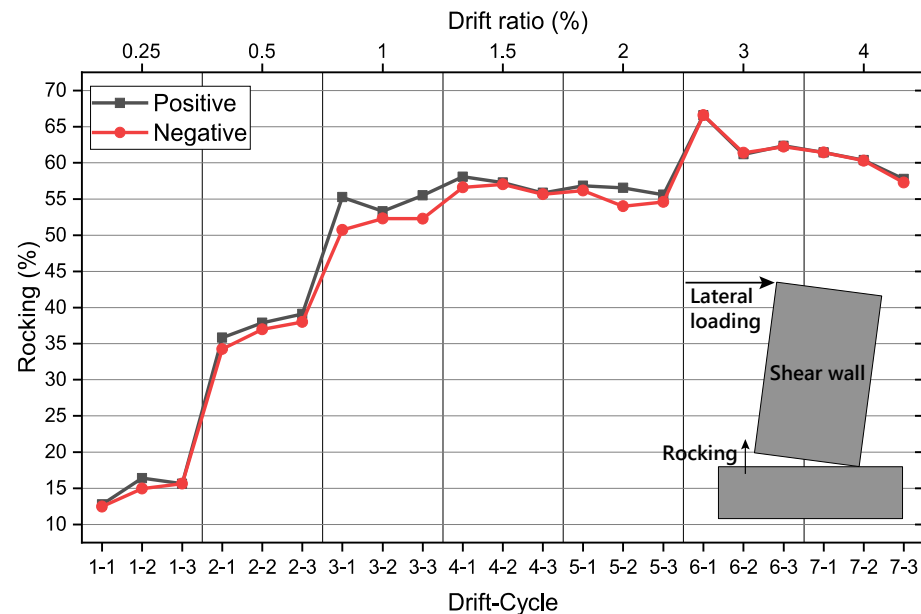
Figure 11. Comparison of lateral displacement caused by wall rocking and total lateral displacement of TUBE specimen.

Figure 11 compares the total lateral displacement and the lateral displacement caused by the TUBE specimen's rocking. The angle caused by the wall's rocking was replaced by the lateral displacement using the wall's height. In the case of the general flexural dominant shear wall, it appeared at the level of 10–20% of the total, but in the case of the TUBE specimen, it was about 12–17% at the initial drift, but it gradually increased as the experiment progressed, reaching 67% at the drift ratio 3%. Initially, the bond between the retrofit and the foundation was expressed, but it was judged that the wall did not bend and lifted as the end retrofit was pulled out, as observed in Figure 10b. The result, which appeared to have a ductile behavior derived from the load–displacement relationship, appeared to be the interaction between the axial load (ALR = 15%) from the top and the lateral load applied according to the overall movement of the wall. In this process, the retrofit appeared to resist only compression, with little resistance to tension. The TUBE specimen's retrofit is similar to a small CFT column, thus it resists compression very
