Field measurement of U-value using multiple sensors at test chamber and EIFS building

The purpose of this study is to analyse the heat flux difference and examine applicability of the heat flux sensor along with various sensor attachment methods. Using multiple sensors and various tapes, a KS F 2278 thermal test was performed in hot/cold chamber conditions with standard panel specimen. The measured heat flux values of sensors were stable. But values of sensors were smaller than the heat flux result of KS F 2278. Thus, thermal resistance of attachment tape on a sensor should be considered during on site U-value measuring process. This study also examined the differences between measured U-value and design U-value by attaching the different sensors in the same area using multiple heat flux sensors. All cases are shown to the same patterns on each heat flux and U-value graph, but U-values with regard to various sensors have shown some differences to the designed values. Using in-situ measurement, the EIFS wall was found to be difficult to measure accurately due to the small level of heat flux.

Heat flux sensor; U-value;
Chamber test; EIFS

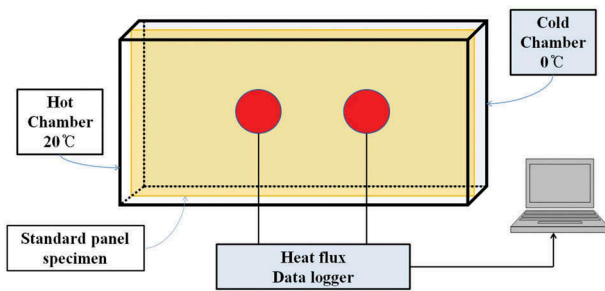
Figure 1. Overview of heat flux measurement device composition using KS F 2278.

Measuring preparation should be completed according to KS L ISO 9869, and each device and all equipment should be connected. Figure 1 shows a diagram of the heat flux sensor, data logger attached to the standard panel specimen (EPS board) between the hot and cold chamber, and computer connection. Figure 2

(a) illustrates the hot and cold thermal chambers as the major devices based on KS F 2278.

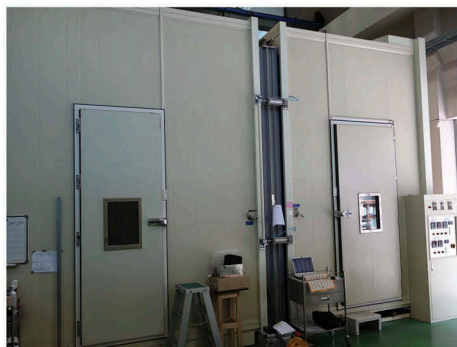
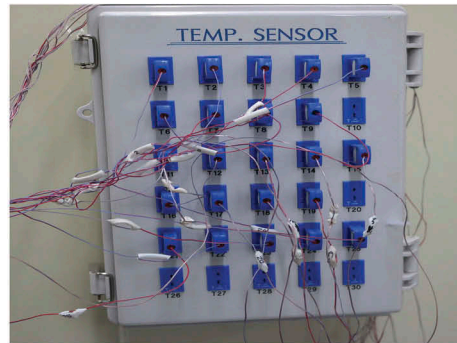
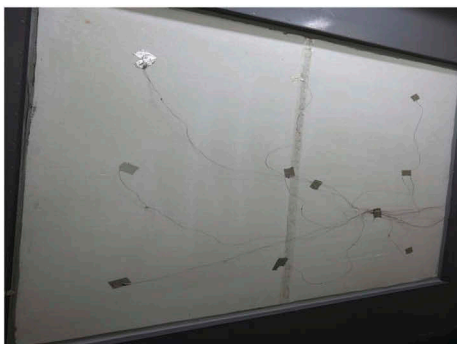
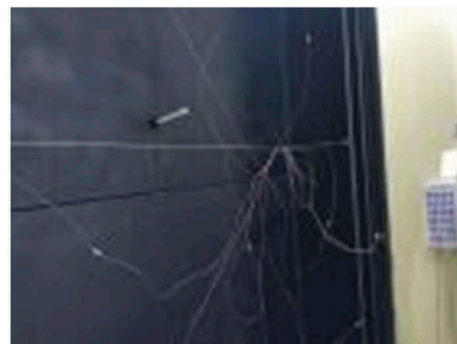
(a) Hot-cold chamber exterior

(b) Temp. sensors

(c) Sensor attachment points

(d) Heating box interior

Figure 2. KS F 2278 chamber and equipments.

according to KS F 2278. Figure 2(b), (c), and (d) indicates the temperature sensors attached to the standard panel within the thermal chamber and the attached state.

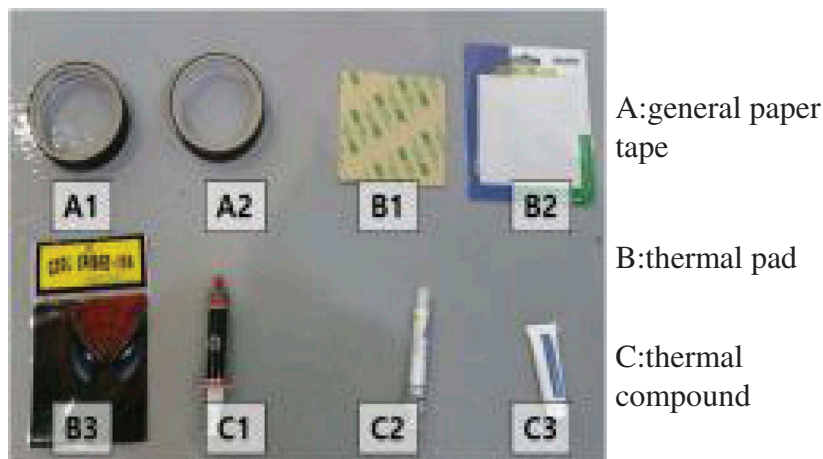
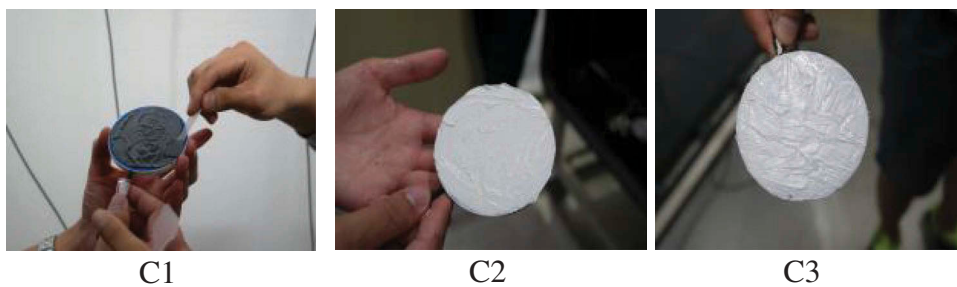
Figure 4. Materials in the heat contact section.

A1 and A2 are the general tape attachment method, equally attached as the preliminary stage test. B1, B2, B3 are the pad method, attached with thermal pads of three types with different heat conduction and thicknesses, respectively. C1, C2, C3 represent a compound method; three types of compounds were utilised, the same as in the pad method. Figure 4 indicates the material of the contact section for each method.

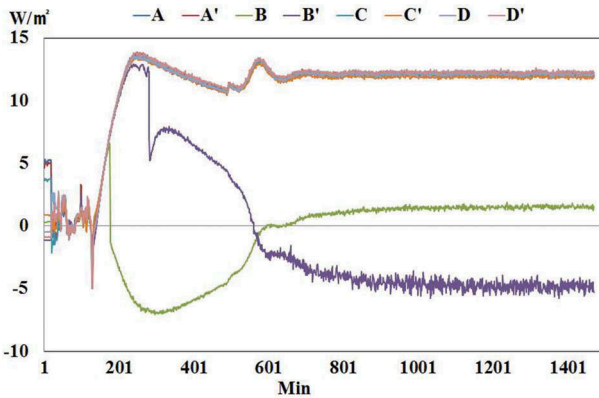
Figure 6. Overall heat flux measured by sensors (1st test).

Figure 6 indicates the entire results of the test period, the overall scope of heat flux value measuring result per each sensor. Figure 7 is a graph that extracts the 90-minute portion representing the stabilized heat flux value in Figure 6. Figure 7 shows the result that heat flux between the same attachment methods, A-A', C-C', and D-D' appeared very similar to each other. Also, similarity among A-C-D attachment types differentiated with fixing method while attaching also was confirmed, however C' and D' sensor heat flux showed relative error in 6.4% in a specific point. And the heat flux of C and C' sensors using thick insulation tape with low thermal conductivity is somewhat lower than other sensors.

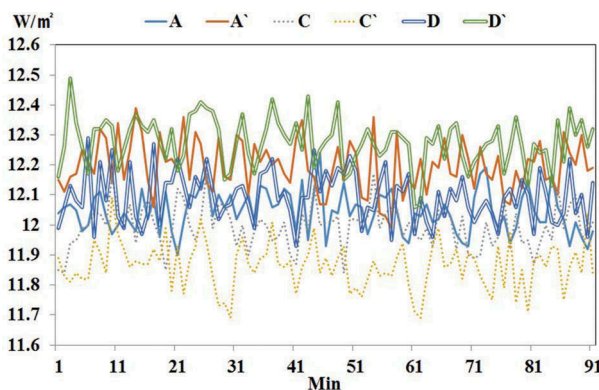
Figure 7. Heat flux measured in stable period (1st test).

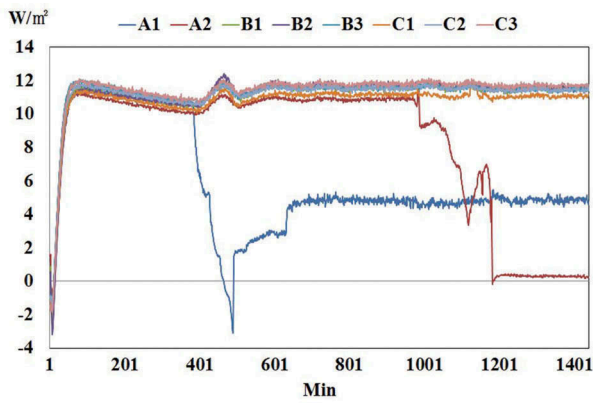
Figure 8. Overall heat flux measured by sensors (2nd test).

Figure 8 indicates 24 hours' sample results, the overall scope of heat flux measuring result per each sensor. Ninety minutes' sample results in the stable period of heat flux per each sensor, as indicated in Figure 9.

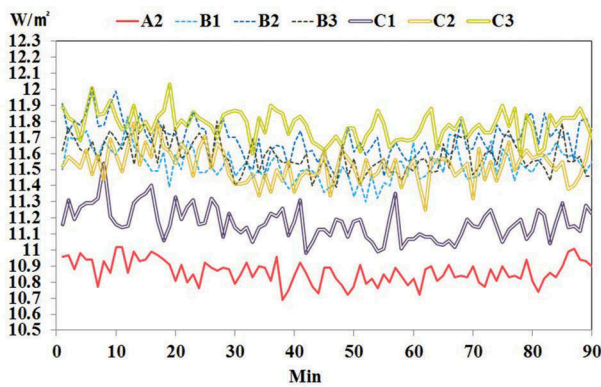
Figure 9. Heat flux measured in stable period (2nd test).

Figure 9 indicates the result that shows very similar values in heat flux in B, pad type, and C, compound

type, except type A. A2 and C3 sensor heat flux, which showed the biggest error, showed relative error of 10.8% at a specific point. This seems to be because method A formed a low value due to the possibility of influence of standard panel surface porosity and air flow between the contact sides. Type B showed relatively stable heat flux according to thermal conductivity due to regular pad thickness; however, as in Figure 4 C1, C2, C3, type C showed difference in U-value measuring value per product without establishing a proportional relation with heat conduction function, since its spread thickness was nor regular due to hand-spread of the compound.

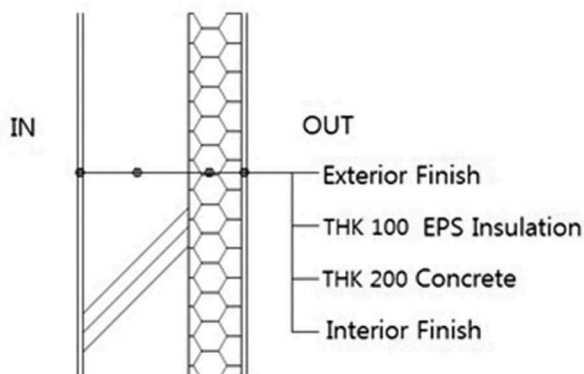
**Figure 10.** Target building and measurement location.

In this study, field measurements were carried out to determine the U-value of heat flux sensors using thermal contact paste. Figure 10 shows the target building to be measured and the measurement location. The outer wall of the building under measurement is composed of adhesive EIFS (exterior insulation finishing system), and the cross-sectional details are shown in Figure 11. Also Table 6 shows the design values of the thermal performance of the building walls to be measured.

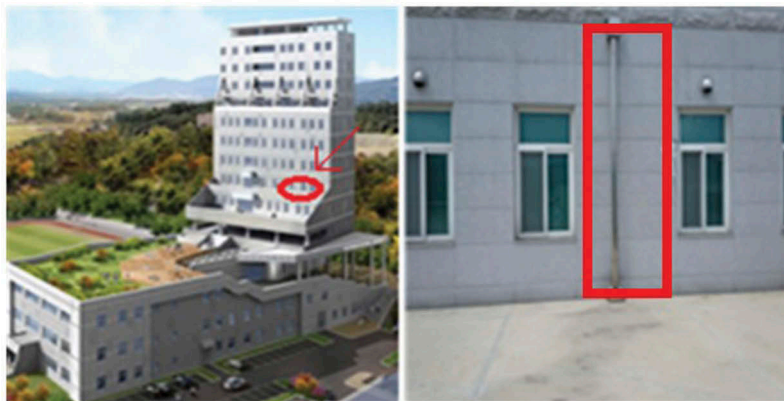
**Figure 11.** Detail of exterior wall.

Figure 12 is a schematic representation of the attachment location according to the heat flux sensor number. The heat flux measurement was carried out twice in the winter, seven days for each case, and the room heating set temperature was 18°C. In order to investigate the tendency of the heat flux value when different sensors are applied to the same location, measurements were conducted for cases 1 and 2. Figures 12 and 13 show the location of the heat flux sensor. In accordance with ISO 9869, each heat flux sensor is attached to the wall surface using a thermal contact pad, and a data logger and a T-type thermocouple are installed for measuring the temperature inside and outside of the room. Figures 14 and 15 show the measured value of the heat flux by each sensor and the temperature difference between indoor and outdoor during a stable period of one day. In Case 1 of Figure 14, the values of HF1, HF2 and HF8 tend to be larger than those of the other six sensors. Case 2 in Figure 15, which means only the arrangement of sensors at the same measurement position as case 1, shows a tendency to be larger than that of HF5, HF6, and HF4 sensors. Since the four different sensors show similar values at the same position, the reason why the left and right side wall heat flux values in Case 1 and 2 are large is not the error of the sensor. It can be considered as a difference according to the change of the cross-sectional state of the wall adjacent to the window.

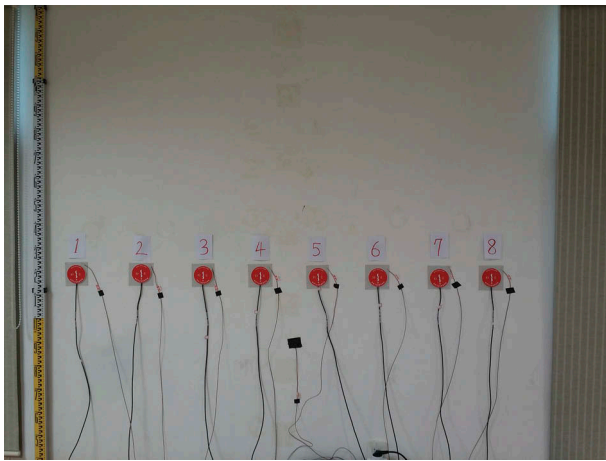
Figure 12. Attachment of sensors and its number (case 1).

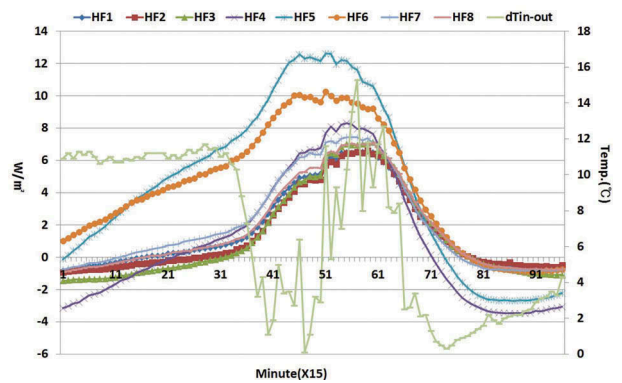
Figure 15. Measured heat flux and in-out temp. (case 2).
