## 경골 골수강 내 금속정 고정술 후 오삽입된 Endcap의 '낚시-바늘' Technique을 통한 제거 - 수술 술기 -

### Extraction of Misplaced Endcap during Tibia Intramedullary Nailing by 'Fish-Hook' Technique - Technical Note -

Se-Hyeok Yun, M.D., Jae-Hyuk Yang, M.D., Ph.D.<sup>✉</sup>

*Department of Orthopedic Surgery, Veterans Health Service Medical Center, Seoul, Korea*

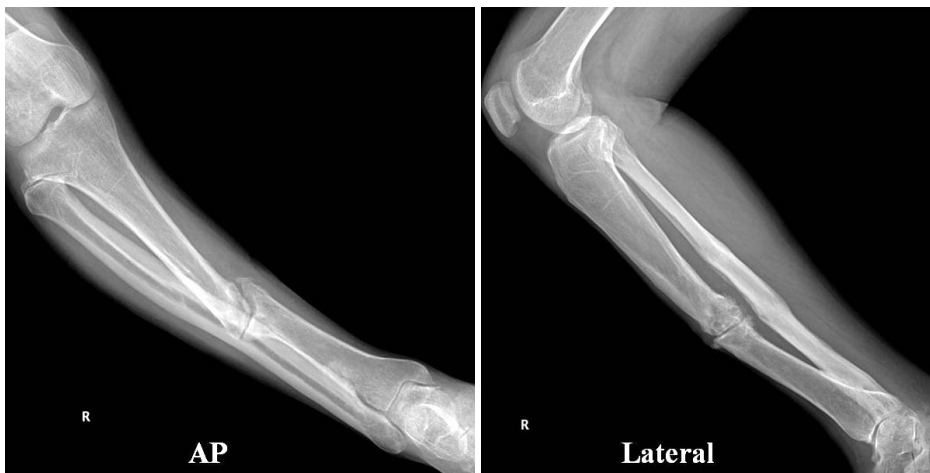
**Fig. 1.** Initial presentation radiograph at our clinic. Non-union and varus angulation of the previous fracture site is demonstrated. Notice the hypertrophied fibular. AP: Antero-posterior.

Center, there was a crust formation with small open wound at previous fracture level with non-union of initial fracture site (Fig. 1). The fibular was hypertrophied compared with the contralateral limb. Magnetic resonance imaging revealed the increased signal intensity and enhancement in superficial and deep soft tissue around fracture site. Bone scan showed similar findings. The culture from the wound was confirmed as methicillin-sensitive staphylococcus aureus. Under the diagnosis of chronic osteomyelitis with nonunion of tibia, 2-stage operation was planned for the patient. For the initial operation, bone resection of the suspicious area and antibiotics (4.0 g of vancomycin in 1 pack of cement) cement beads were inserted. Other fixative devices were not applied at initial operation due to acceptable stability perhaps due to hypertrophied fibular. Five weeks after operation, C-reactive protein level was normalized without infection sign. The patient was returned to operating room for antibiotics cement beads removal and ti-

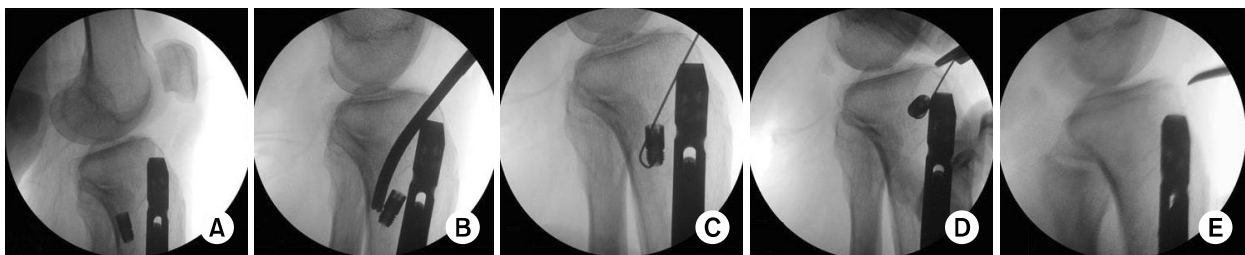
**Fig. 2.** (A) Endcap misplaced at the metaphyseal area of the proximal tibia posterior to the intramedullary nail. (B) Curved long Kelly forceps appear to displace the endcap further distally and anteriorly. (C) Without violating the anterior cruciate ligament footprint area, the fish hook K-wire was successful in holding the misplaced endcap. (D, E) Finally, the endcap was extracted.

As a last step, endcap insertion was tried. Although the guidewire was used, endcap somehow was misplaced to the metaphyseal area of proximal tibia (Fig. 2A). Multiple attempts was tried to extract the endcap using the curved Kelly forceps, but failed (Fig. 2B). To avoid further damage of the bone and soft tissues, smaller extraction device was needed. So, 1.6-mm Kirschner wire was bent in a 'fish-hook' fashion, where the tip was long enough to hold the endcap hollow area (Fig. 2C-E).

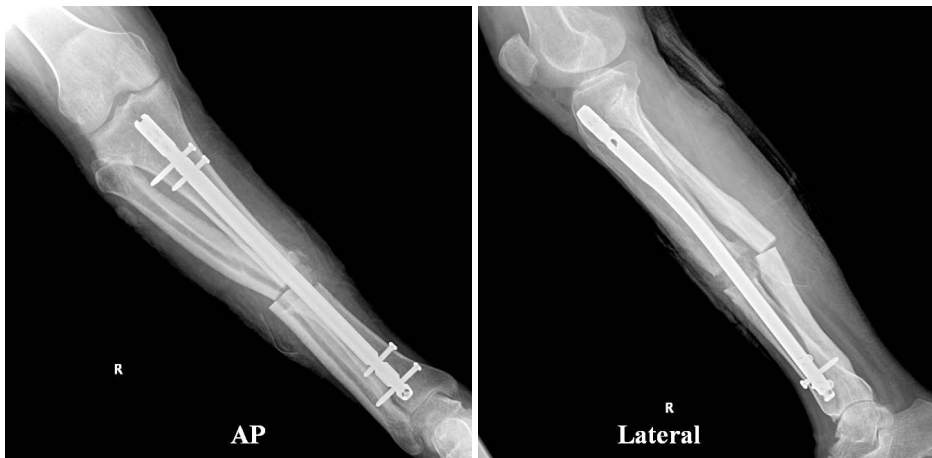
**Fig. 3.** Immediate postoperative radiographs. AP: Antero-posterior.

By using this simple device which can be readily made at ordinary operative rooms, the misplaced endcap was successfully removed (Fig. 3).
