Repeated Periprosthetic Femoral Fracture in a Below Knee Amputee with Ipsilateral Cementless Total Hip Arthroplasty - A Case Report -

Department of Orthopedic Surgery, Veterans Health Service Medical Center, Seoul, Korea

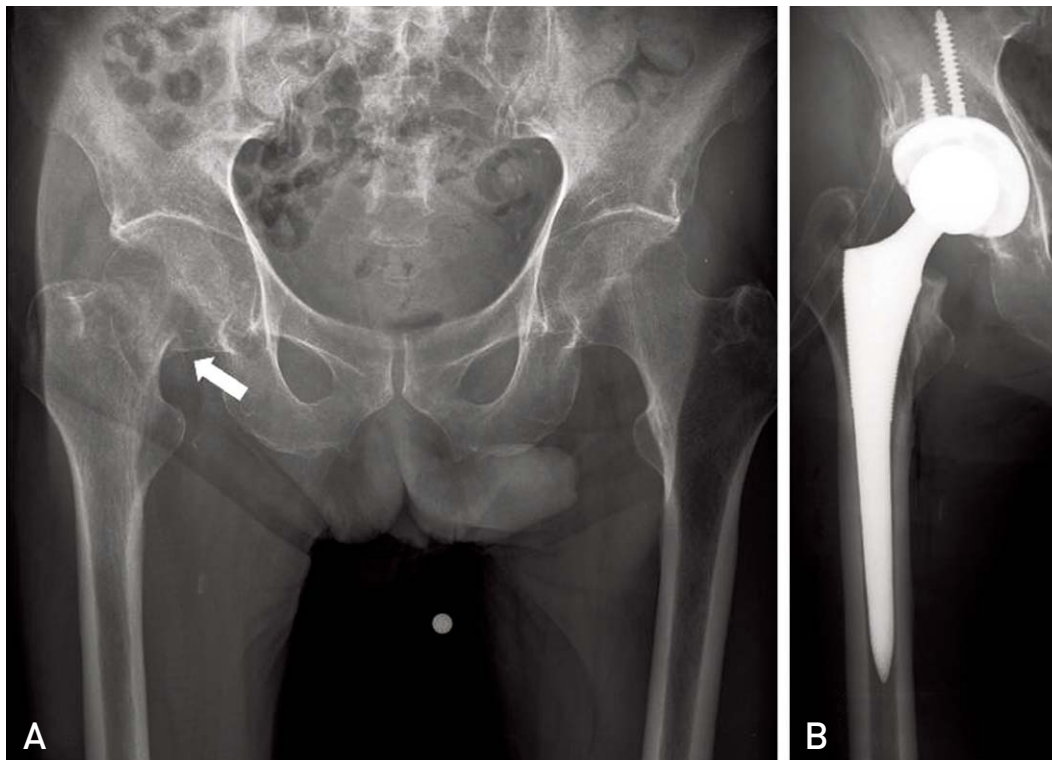
Fig. 1. (A) Pre- and (B) postoperative anteroposterior radiograph. Postoperative radiographs revealed an acceptable implant position.

In January, 2010, a 69-year-old Vietnam War veteran presented with right hip pain developed after slip down. He had a background history of below knee amputation for his ipsilateral right leg from severe gunshot injury 40 years ago. Radiographs revealed a displaced subcapital femoral fracture (Fig. 1A). Bone mineral densitometry revealed T-score of -3.2 on the contralateral femoral neck area. The patient was treated with a cementless THA (Summit, DePuy®, U.S.A) using a posterolateral approach with a regional anesthesia. Prior to surgery, the patient was able to ambulate three to four blocks with a cane and negotiated stairs in a non-reciprocating manner (Harris hip score¹¹, of 90). Postoperative radiograph after THA showed satisfactory implant positions (Fig. 1B). On the 14th postoperative day, he was able to

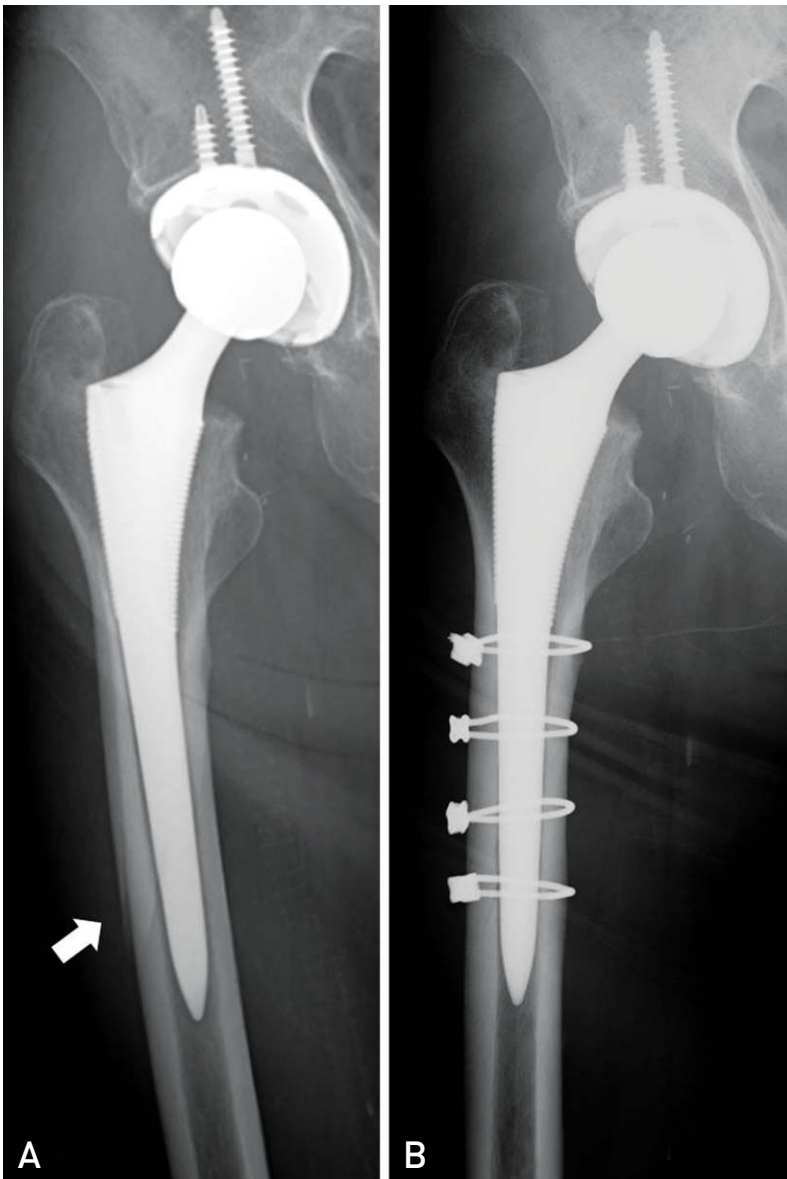
Fig. 2. First periprosthetic fracture. A Vancouver type B1 periprosthetic femoral fracture was stabilized by the multiple cerclage wires. (A) pre- (B) postoperative anteroposterior radiograph.

Two months after his THA operation, the patient visited outpatient clinic complaining of right thigh pain with swelling which occurred after slip down while removing his prosthesis. Radiographs revealed a Vancouver type¹². B1 postoperative peroprosthetic femoral fracture (Fig. 2A). It was a spiral fracture with minimal displacement. The previous implanted femoral stem seemed to be in well-fixed state compared to previous follow-up radiographs. Fracture management was done by open reduction with cerclage wiring (Fig. 2B). Four weeks after periprosthetic femoral fracture operation, he was permitted to ambulate using the walker. Walking exercise with parallel-bar was encouraged thereafter for another four weeks.

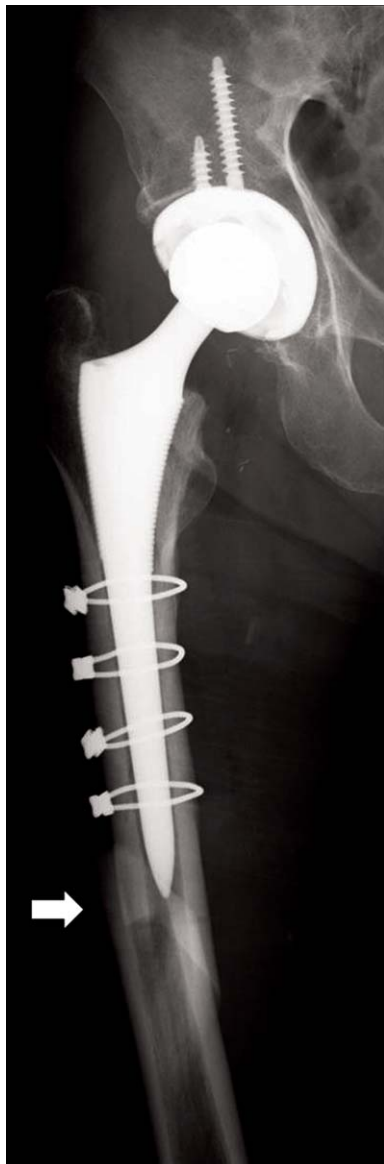
Fig. 3. Second periprosthetic fracture. A Vancouver type B1 periprosthetic femoral fracture (arrow) occurred at the tip of femoral stem.

The patient revisited with painful thigh swelling which was developed about three months after the 2nd operation. The patient claimed that the swelling developed after walking exercise without major traumatic event. Radiographs demonstrated a Vancouver type¹². B1 postoperative periprosthetic femoral fracture (Fig. 3). The fracture line was at the distal portion of the femoral stem tip. It was short oblique pattern, with displacement. The femoral stem, however, was still in

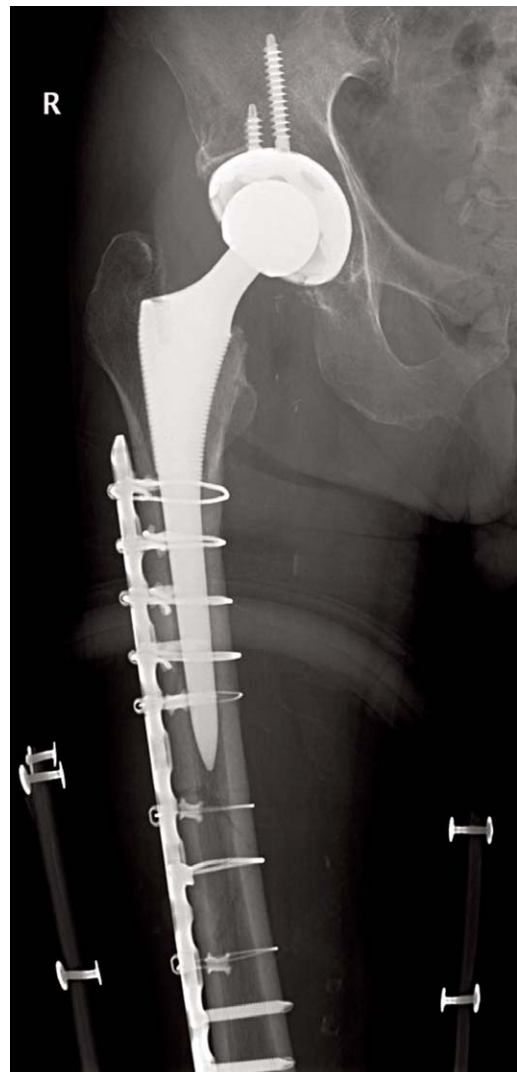
Fig. 4. Fracture stabilization was performed by use of locking plate.

well-fixed state compared to previous radiographs. Fracture stabilization was performed by use of plate (Broad curved locking compression plate, Synthes®, Switzerland) together with 15 cc of auto cancellous iliac bone graft (Fig. 4). Intraoperatively, previous operated Vancouver type B1 femoral fracture (spiral pattern) site was healed with good stability. Postoperatively, the patient was allowed to ambulate with ischial supported long leg prosthesis using bilateral crutches. Partial weight bearing was permitted after 3 weeks. In supine position, range of motion in his hip and knee joint was encouraged. Fracture was healed at 9 months postoperatively. At latest follow up (2 years after initial THA operation), he presented with Harris hip score of 80.
