Experimental Evaluation of Water Supply Pipe Joints against Seismic Ground Deformation: A Four-point Bending Test

Keywords: Four-point bending test, Ground deformation, Seismic properties, Water supply pipe joint.

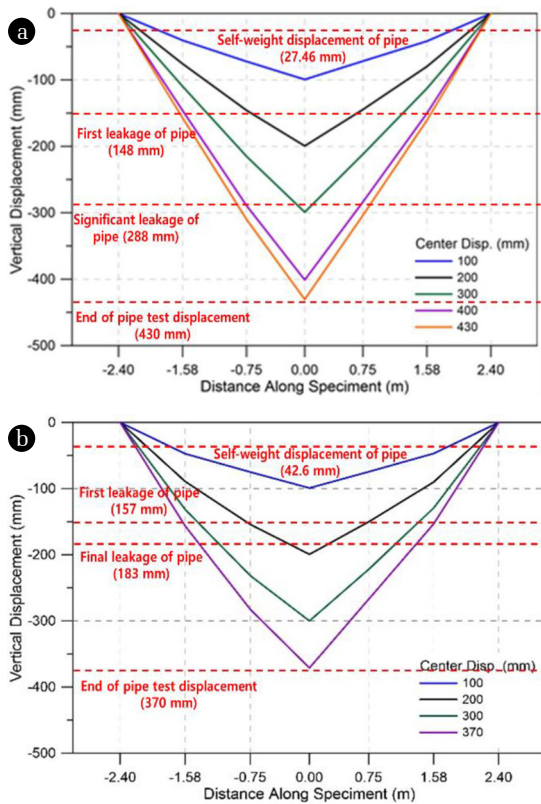
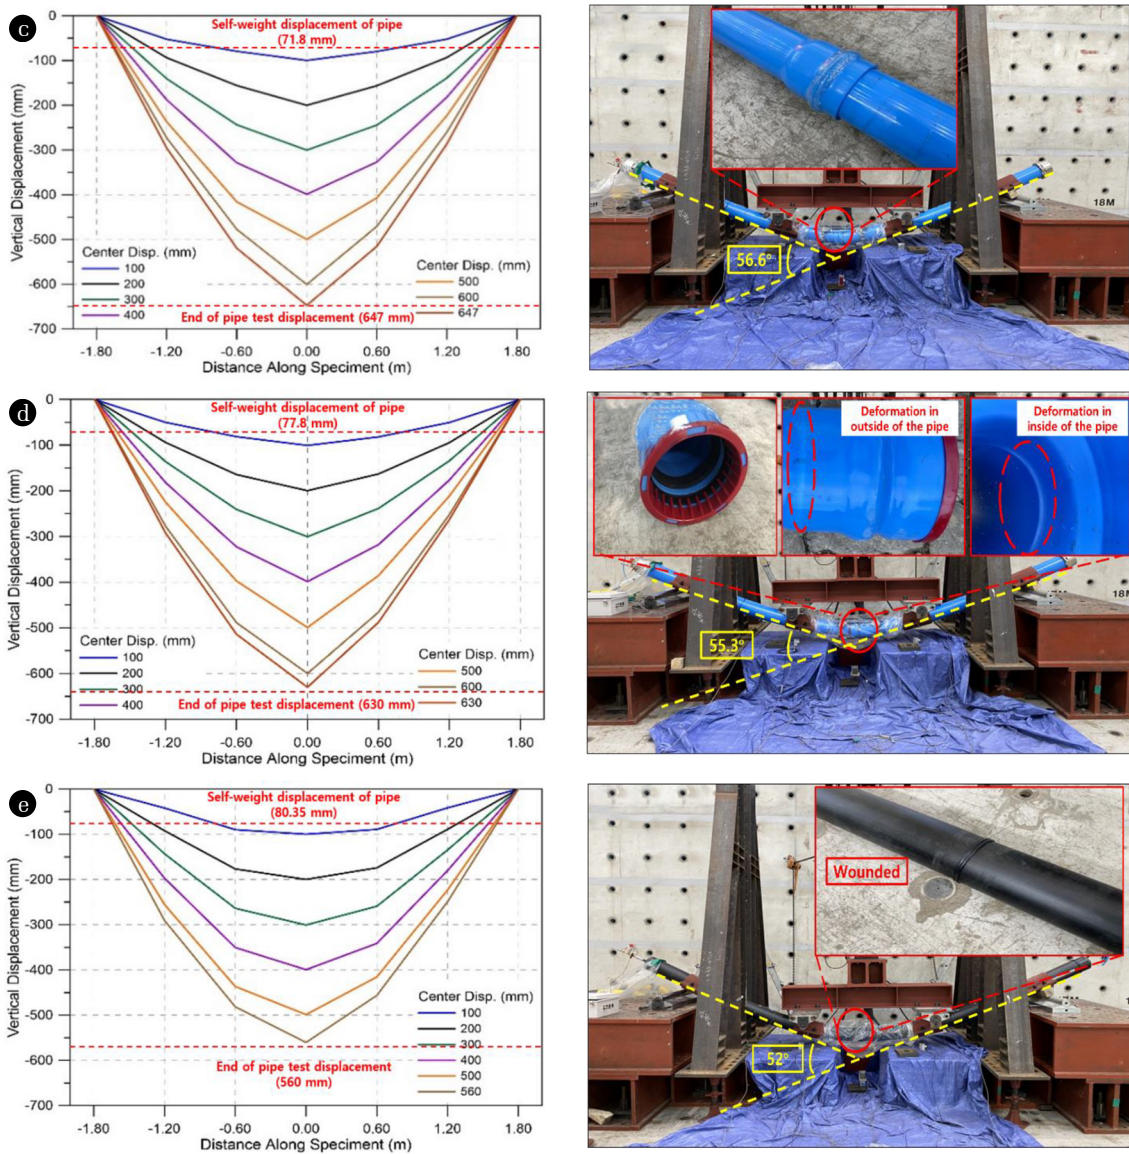
Fig. 2. Axial displacement of each test specimen. a: FDK_1 (Four-point bending test_DI_KP mechanical joint); b: FDC_2 (DI_Collar connection joint); c: FHS_3 (HI-VP_Socket joint with one rubber-ring); d: FHS_4 (HI-VP_Socket joint with two rubber-ring); e: FPF_5 (HDPE_Fusion bonding).

Fig. 2. Continue

Fig. 2 shows that each test specimen shows good agreement between the vertical movement measurements at equal distances from the center (joint) point of the test. The continuous progression of these displacements is further indication that the assumption of specimen motion in Eq. (1) can be used to determine its rotations. In the middle of the test, FDK_1 (Four-point bending test Ductile iron KP mechanical joint) and FDC_2 (Four-point bending test Ductile iron Collar mechanical joint) lost their function with vertical

displacements of the leakage marked in Fig. 2(a) and (b). The results also describe the joint in the form of deformation and fracture at the maximum vertical displacement of FDK_1 and FDC_2 [24]. In the DI test specimen pipe results, the deformation of the pipe was insignificant. However, the deformation and deflection angle which occurred at the joint caused the loss of function. However, the rest of the non-metallic pipes did not lose their function, rather they reached the maximum vertical displacement of the MTS actuator. Due to the non-metallic pipe results, the deflection degree was assumed to be their maximum vertical displacement [29].

The joint deflection degree of each test specimen was confirmed using Eq. (1) with adding the self-weight displacement length shown in Fig. 2. Table 4 summarizes the joint deflection degree of each specimen. According to Eq. (1), the joint deflection degrees of FDK_1 at the forced first leakage and leakage at the time of pipe failure

In Fig. 2(c)-(e), the shape of the pipe itself became deformed in the case of non-metallic pipes. As shown in Fig. 2(c) and (d), the pipe insertion hole rotated inside the socket and a large flaw occurred at the lower end. Fig. 4 shows the moment value and strain of the specimen. The tendency of SG-3, 4, and 5 in non-metallic test specimen was larger than that of SG-1, 2, 3, and 4. Unlike metallic pipes, non-metallic pipes showed similar results in the upper and lower sides of the strain gauge. For FHS_3 and FHS_4, although the structural shape of the socket part was different than HI-VP material, similar results (strain result value, each displacement step) were obtained. Since the material of FPF_5 is more flexible, the maximum moment result value was at the quarter level compared to FDK_1 and FDC_2. The moment value of each specimen shows a gentle trend and when the maximum amount of displacement is reached, the strain at the center of the specimen (SG-3, 4, 5, 6) and at both ends (SG-1, 2, 7, 8) showed a difference of about 3 times or more. As the shear force of the socket located in the center increased, the stress and bending angle increased.

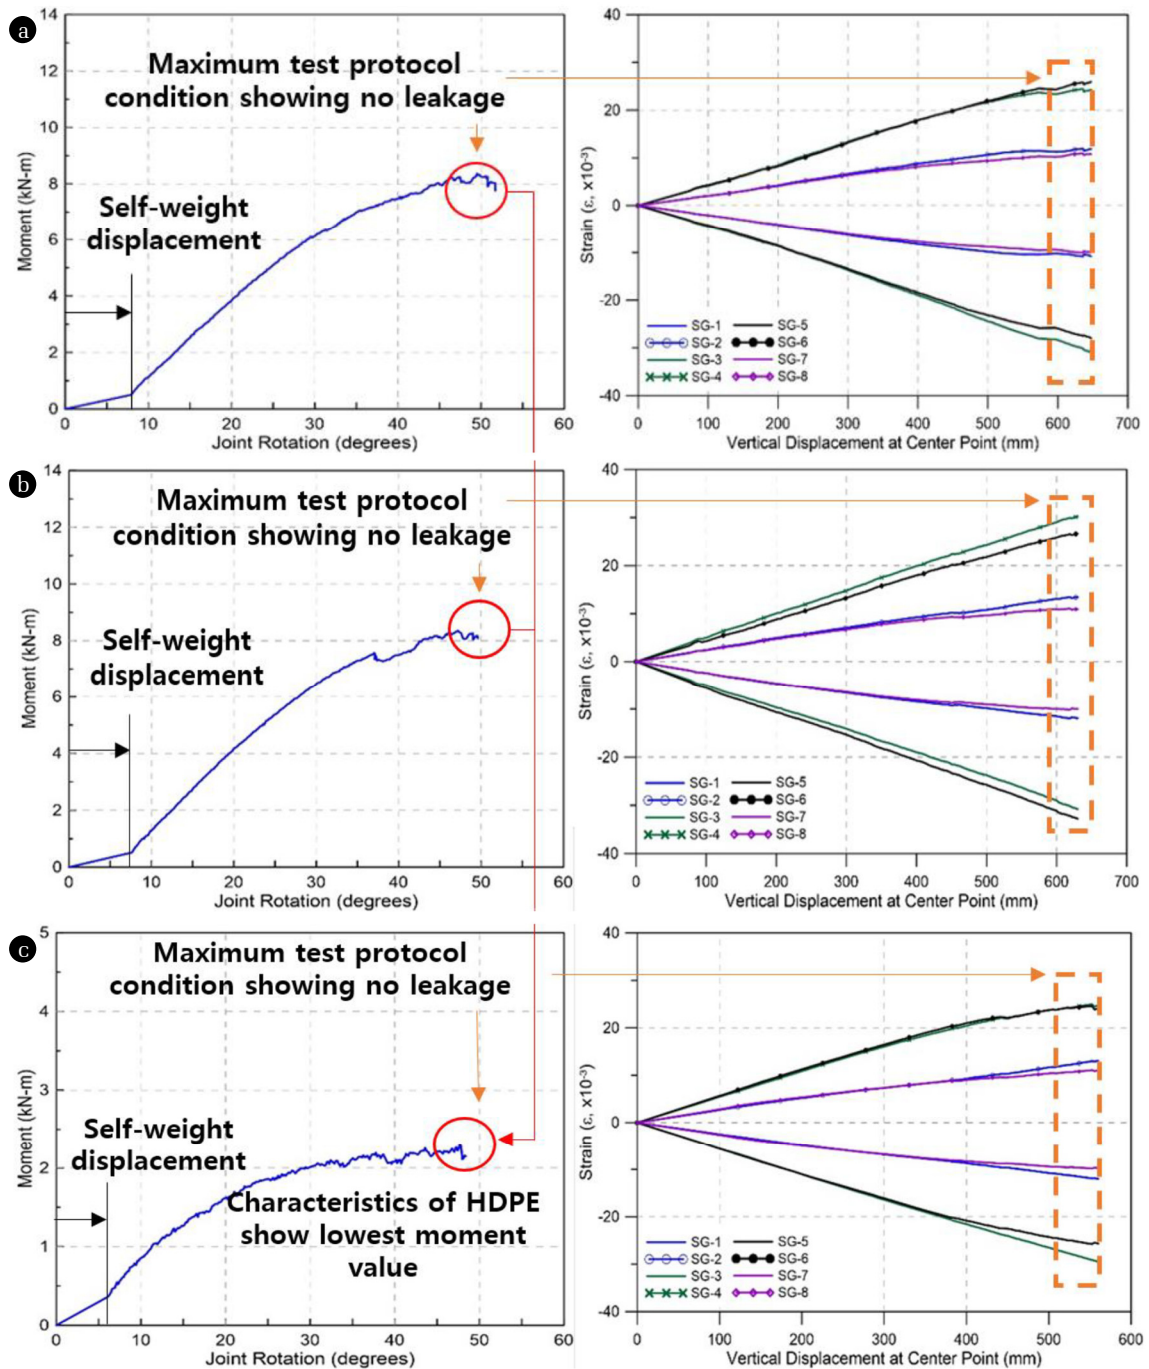
Fig. 4. Moment-rotation and strain response of each test specimen. a: FHS_3 (HI-VP_Socket joint with one rubber-ring); b: FHS_4 (HI-VP_Socket joint with two rubber-ring); c: FPF_5 (HDPE_Fusion bonding).
